Meter Audits in the Industrial Areas of the City of Tshwane

Keywords: Management Information System; Industrial consumer meter audits; Increased revenue.

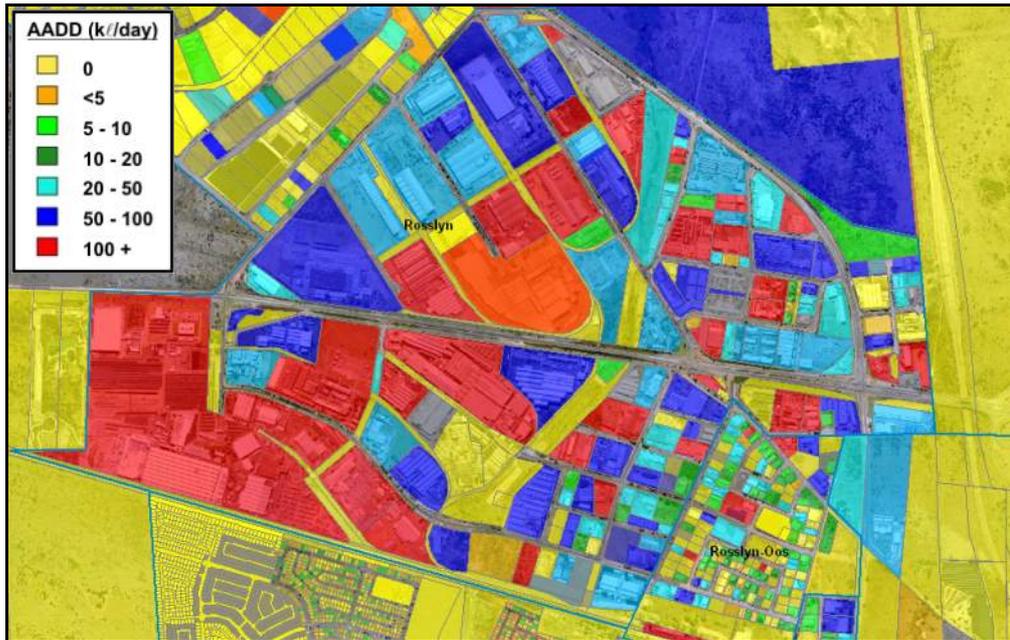
Figure 3: Screen from Management Information System of the City of Tshwane showing the Average Annual Daily Demand (AADD) for the different stands in an industrial area.

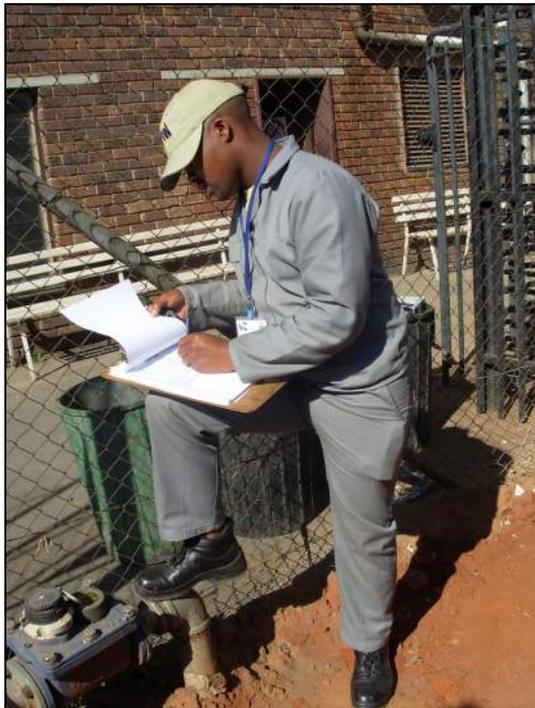
Figure 5: Example of a field technician completing a form during a meter audit exercise undertaken in the industrial areas of the City of Tshwane.

Field inspections were carried out which included the identification and capturing of all relevant meter information, meter readings, problems observed with the meter installations and consumer details (see **Figure 5**). The typical problems identified during the field investigations included illegible meters, buried isolating valves which had to be exposed, broken meters, stolen meters, incorrect meter installations, un-metered connections and erratic meters. A standard form was prepared for the capturing of all the information. Where possible a copy of every consumer's water bill was requested and attached to the capturing form for the verification of meter and account details.

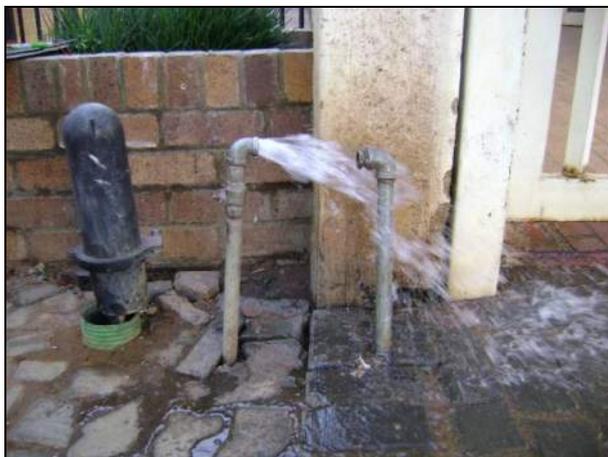
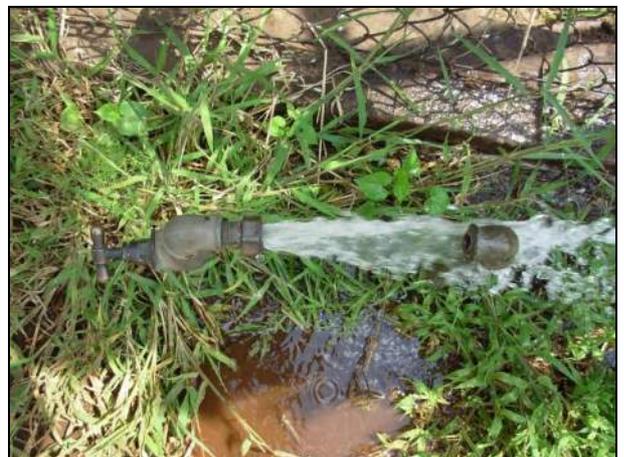
Figure 6: Photos of connections where meters had been stolen or unlawfully removed.

- The first priority was to install meters for connections where meters had been stolen or unlawfully removed. (see **Figure 6**)
- Meters were installed on all un-metered connections (see **Figure 7**). Many of the older stands had un-metered fire connections, and in some instances these pipes had been connected to the normal reticulation of the stand;
- Meters that were illegible, broken or severely erratic were replaced. A summary of the meter installations and repairs per area are summarised below.
- At a few stands water leaks were identified upstream of the consumer meters. These leaks were repaired during the meter replacement exercise.
- Meters which were located inside stands were moved out to the roadside in an effort to simplify the reading of the meters by the municipal meter readers.
